Waterside Mansion of Esma Sultan within the Scope of Contemporary Restoration Work

Keywords: Restoration, Esma Sultan Mansion, Reuse, Revitalization, Renovation.

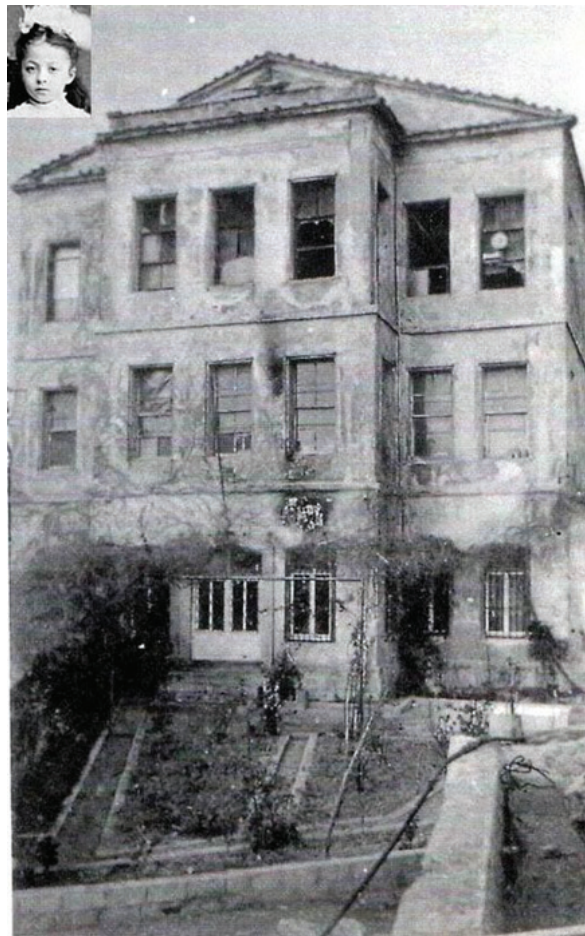
Figure 4: Historical Esma Sultan Mansion⁵

The overhangs in the building are designed with three windows and there are triangular pediments⁴. Today, the historical mansion serves various organizations such as meetings, weddings and special events. Esma Sultan Mansion is among the magnificent historical seaside palaces in the province of Istanbul, and it is one of the most important historical structures in terms of its visual beauty.

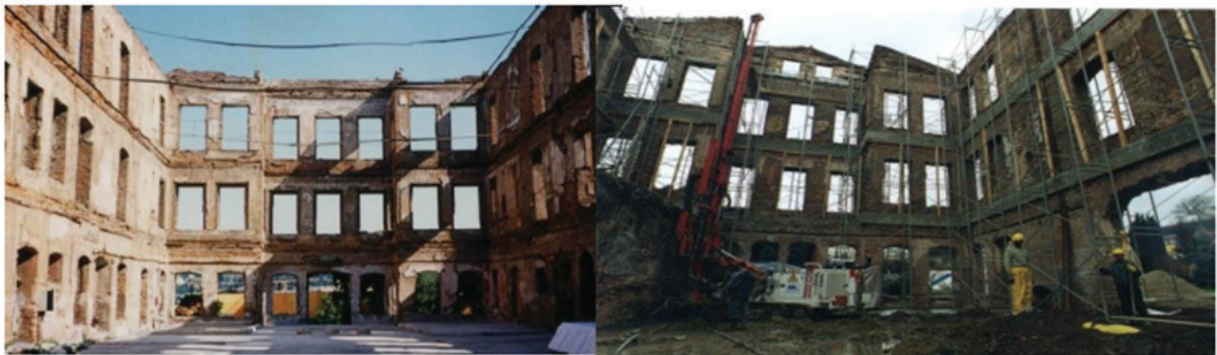
Figure 5: The Historical Esma Sultan Mansion After the Fire
(<https://www.ekoyapidergisi.org> › 1165-mini-portfoy-gokhan-avcioglu, (12.03.2023).)

The historical mansion was used as a storage building and a carpenter's workshop until a fire broke out in 1975. The historical mansion, which was destroyed by the fire in 1975, is now operated by the Marmara Group and serves various organizations. The renovation project was drawn and implemented by Haluk Sezgin and Architect Philippe Robert³.

The historical building was destroyed by the fire, and only the brick outer walls have survived to the present day. It is a mansion that draws attention with its rich wall and ceiling decorations. In the garden of the mansion, there is a cistern, Turkish bath, kitchen and barn structures and a wooden two-storey outbuilding. Due to its topographic location, the mansion has a uniquely beautiful view.

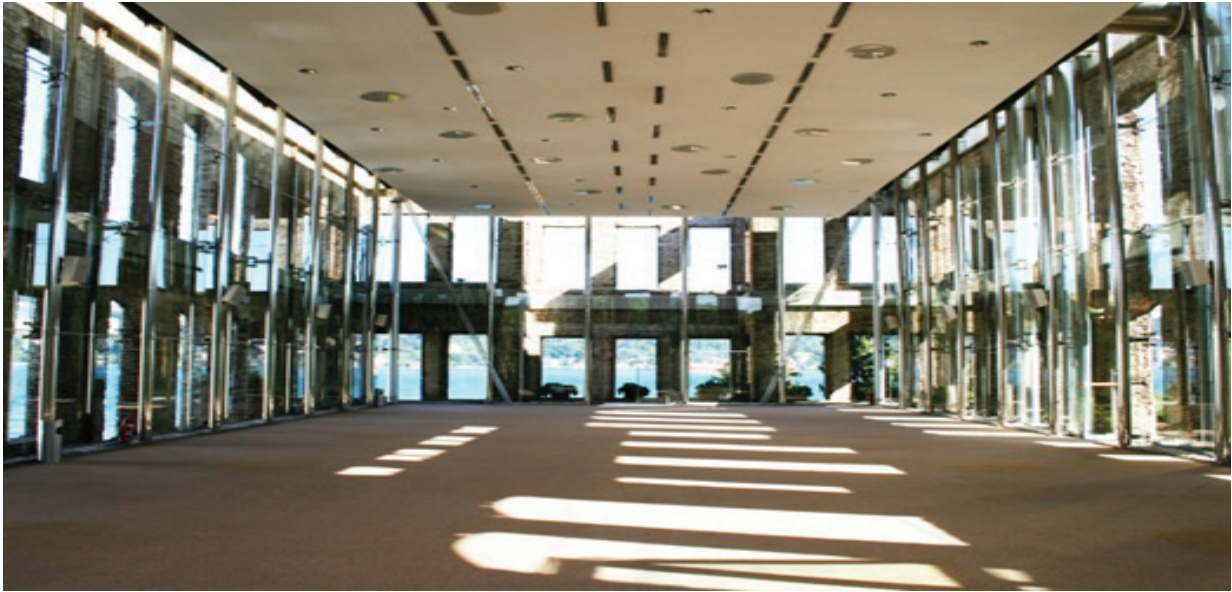
Figure 8: Historical Esma Sultan Mansion Interior View (<https://www.ekoyapidergisi.org> › 1165-mini-portfoy-gokhan-avcioglu, (12.03.2023).)

In Esma Sultan Mansion, which has been re-functionalized, there is a bar and restaurant on the ground floor, and on the second floor, which is accessed via a steel staircase, there are spaces used as a conference hall or event space.
