An Investigation of Urban Furniture Use at Topkapı Earthquake Park

Abstract

Table 1. Research Area Features (URL-5; URL-6).

Table 2. Research Results

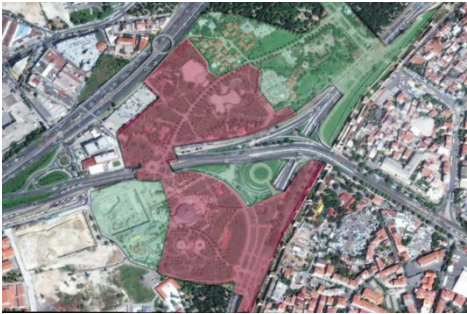
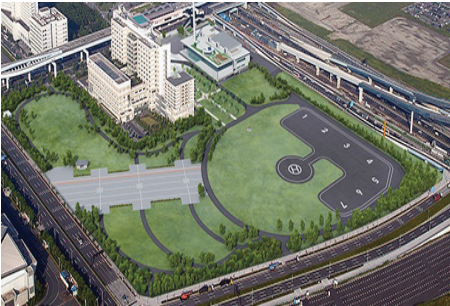
Year of Construction	2009	2011
Location	Istanbul Türkiye	Tokyo, Japan
Coordinates	41.02007506434505, 28.920506988651475	35.635053982888145, 139.795813931777
Project Area	160,000 m ²	132,000 m ²

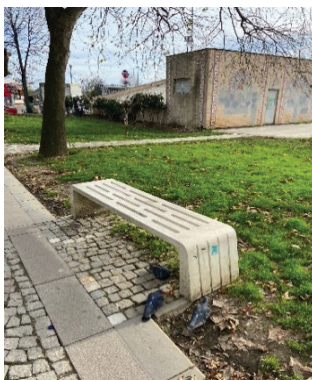
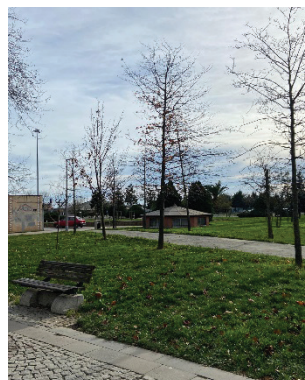
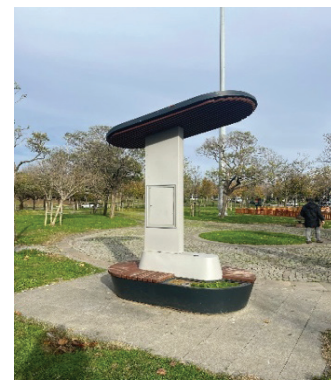
Topkapi Earthquake Park	Tokyo Rinkai Earthquake Park
Sitting Elements		
Benches placed at every 100 meters (Min.) to 200 meters (Max.)	✓	X
Benches that transform into grills	X	✓
Availability of smart banks (Benches with charging stations powered by solar energy)	✓	✓
Movable sitting group positioned in empty areas for emergency use	X	✓
Use of reinforced concrete or stone	✓	✓
Availability of picnic tables	X	✓

The benches, which featured grill systems in order to provide a practical solution for people's need for hot food were not available in Topkapı Earthquake Park. These multipurpose

benches may prove to be convenient following an earthquake and are recommended to be placed in the park for faster food preparation needs. The smart benches, which were produced and placed to meet communication and transportation needs during the first 72 hours following a disaster, were located in the correct locations in both parks. These solar powered benches were functioned with a charging station. Reinforced concrete and stone were used in both parks. These materials were used especially to mitigate the risks associated with natural disasters (fire, etc.). People of all age groups need sitting groups where they can relax and assembly in the park area (Komar, 2021). Picnic tables were used in Tokyo Rinkai Earthquake Park to meet these needs. The same were not available in Topkapı Earthquake Park and it was necessary to do so.

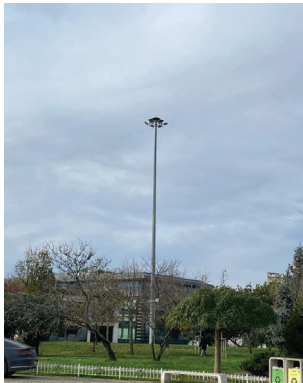
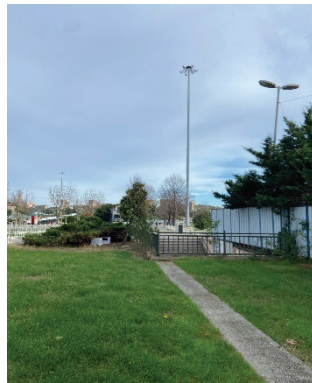
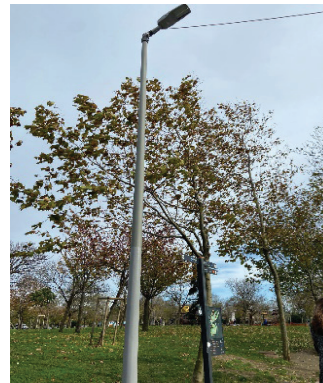
Lighting Elements		
Use of low energy consuming lamps	✓	✓
Availability of floodlights intended for the assembly area and emergency areas	✓	✓
Availability of solar powered lamps	X	✓
Adequate ground lighting	X	X

The lighting elements in use were generally adequate in both parks. For example, projector lamps and low-energy lamps were used at regular intervals to illuminate the assembly areas and emergency areas in both parks. Solar energy is recommended in case of a natural disaster, which can provide a temporary solution, instead of mains that may not be available upon a disaster. Accordingly, unlike Topkapı Earthquake Park, Tokyo Rinkai Park used solar

powered lamps. The ground lighting was not adequate in both earthquake parks. Ground lighting is recommended to guide people accurately and quickly. Upon a comparison of the sitting elements in use both parks, those in Topkapı Earthquake Park were not adequate. As regards the top cover elements, where people can feel safe and protected under furniture elements such as tents or gazebos were available in Tokyo Rinkai Earthquake Park, but there were no shade elements in Topkapı Earthquake Park. It is recommended that shade elements should be designed and placed appropriately in the Topkapı earthquake park. Trash bins were available in both parks in the form of smart and large trash bins placed at a minimum of 100 and a maximum 200 meters from each other. Upon measurements in Topkapı Earthquake Park, it was anthropometrically suitable and at a sufficient level with 45x50x105 cm (Caymaz & Komar, 2021). In both parks, signboards were strategically positioned every 100-200 meters to provide an effective guidance and information system. A park map made available map at the entrance is an important element to easily direct people. Furthermore, both parks featured signs indicating assembly points, informative sign systems containing emergency numbers, and directional signs indicating emergency exits (Çelik & Ender, 2016). A map of the park layout was provided in an easily-understandable format for the convenience of the public at the entrance, guiding people to explore and use different areas in the park. Therefore, the signboards were adequate at Topkapı Earthquake Park. In general, it is suggested that in order for the urban furniture of both parks can be used effectively in disaster situations, the sitting elements and lighting elements should be improved, their deficiencies should be completed, and top cover elements should be made available (Önal, 2019). Furthermore, the availability of adequate trash bins and signboards was considered a positive aspect.

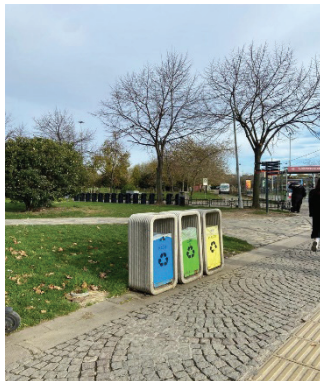
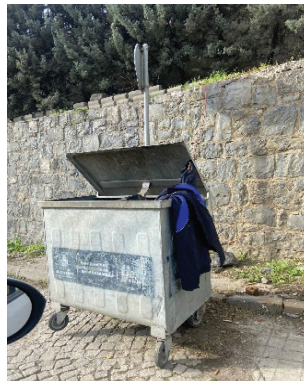
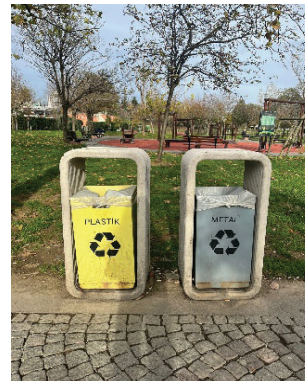
Top Cover Elements		
Availability of shade elements	X	✓
Existence of gazebos to meet the shelter need after an earthquake	X	✓
Availability of tents ready for use after an earthquake	X	✓

Trash Bins		
Availability of smart trash bins	✓	✓
Availability of large trash bins	✓	✓

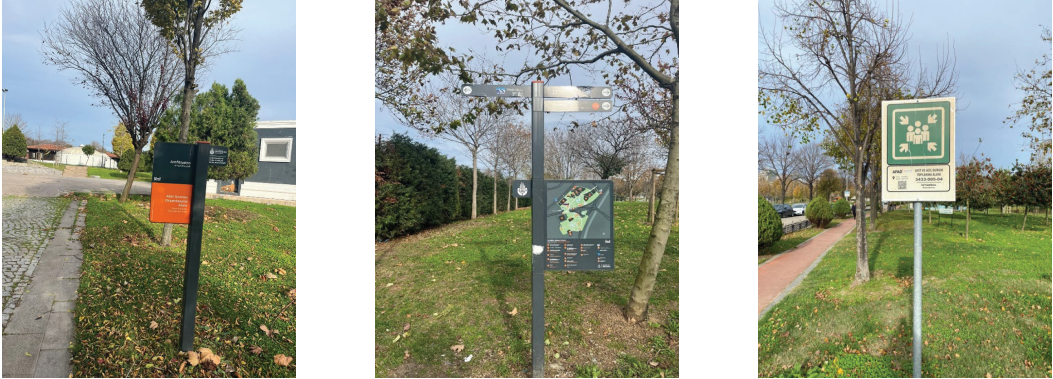
Signboards		
Park map at the entrance	✓	✓
Signs indicating assembly points	✓	✓
Informational signage systems with emergency numbers	✓	✓
Direction signs showing emergency exits	✓	✓

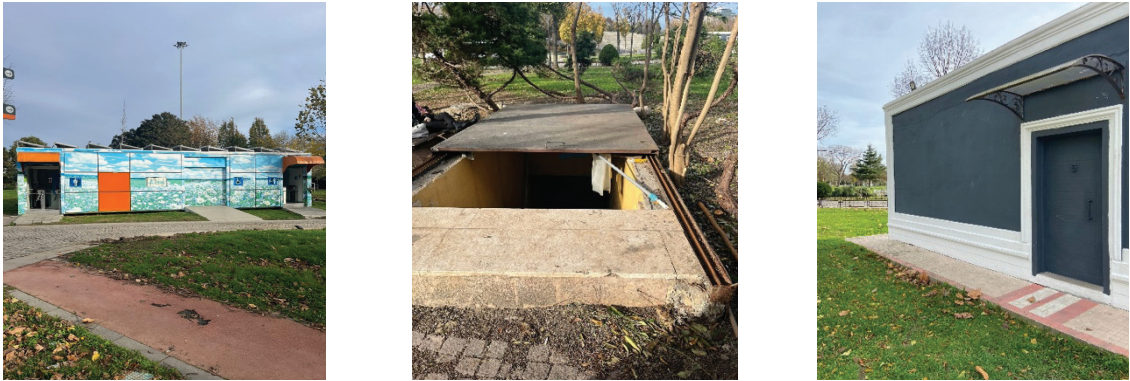
Support Service Personnel		
Security cameras	✓	✓
Manhole toilets	X	✓
Container WC	✓	✓
Changing rooms	X	X
Showers available	✓	✓
Emergency shelter	✓	✓

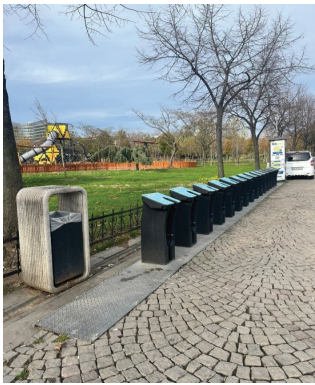
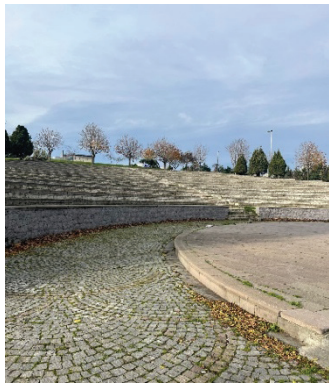
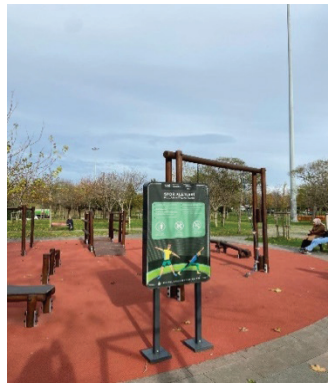
Other Furniture Elements		
Food and beverage vending machines	X	✓
Sports equipment	X	X
Children's playground elements	✓	X
Availability of Amphitheatre-type of sitting area	✓	✓
Availability of bicycle parking spaces	✓	X
